RL-TR-96-98
Final Technical Report
July 1996

RELIABILITY ASSESSMENT OF OPTO-ELECTRONIC INTEGRATED CIRCUITS

Uniphase Telecommunications Products

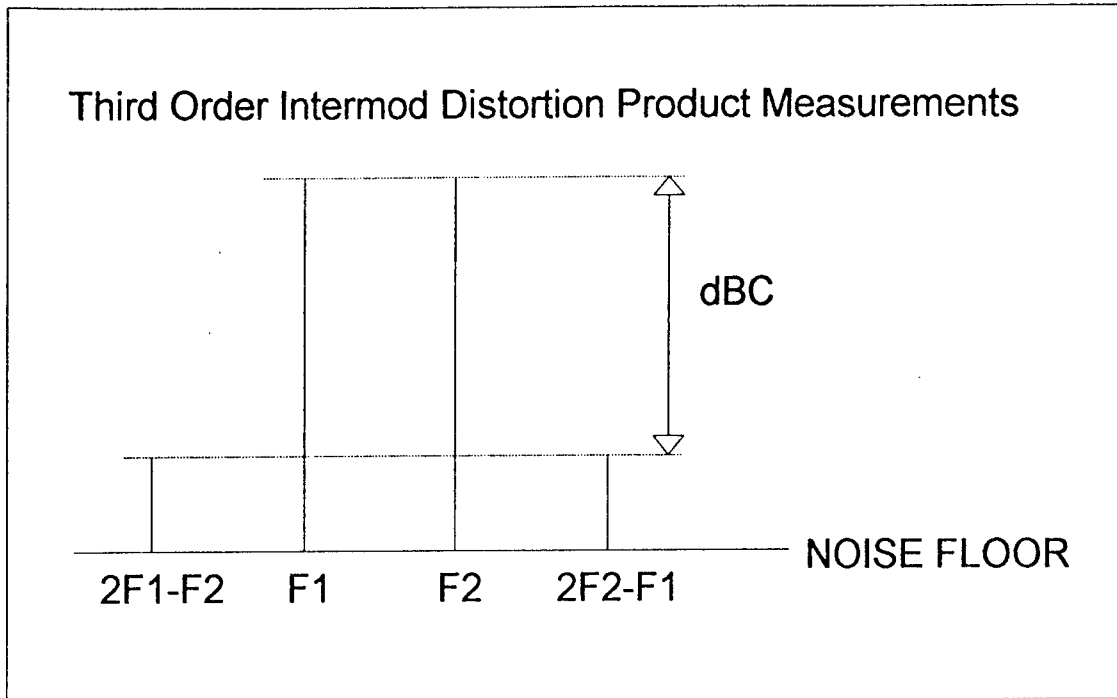
Figure 3: Intermodulation measurement.

$$V_{\pi} = \frac{\pi \cdot V_{rms}}{2 \times 10^{-D/40}} \quad (2)$$

4) Half-wave voltage, V_π , was always measured to be below 1.06 V for all BCM devices. No trend was observed for V_π vs. exposure time. In some cases, the measured V_π dropped to abnormally low values. For example, in Lot 2 the V_π was measured to be 0.4 V at 250 hr and then returned to approximately 1.0 V at 500 hr. These dropouts in V_π are likely to be an artifact of measurement. V_π is measured from the relative level of the 3rd order IMP's (Inter-Modulation Products), which are illustrated in Figure 3. The formula used to calculate V_π from the 3rd order IMP, given by Equation 2, assumes an ideal bias point. In that equation, V_{rms} is the RMS voltage of the applied tones and D is the level of the 3rd order IMP relative to the main tones. The level of the 3rd order IMP increases when the bias point moves away from the ideal, causing D and the measured value of V_π to both decrease. The bias point was off by 76° when V_π was at its measured value of 0.4 V; therefore, the V_π drop is probably a measurement artifact. Another contributor to measurement error is noise which creates uncertainty in the small signals levels of the IMP's. These error sources can be eliminated in the future by using a more direct means of V_π measurement. For example, V_π can be measured at the same time that the modulator extinction measurement is made, by recording the difference in applied voltages for the on and off states.

V_{π} should be measured directly when the modulator extinction is determined. Deducing V_{π} from 3rd order IMP's introduces errors that cause the measured value to be smaller than it really is.

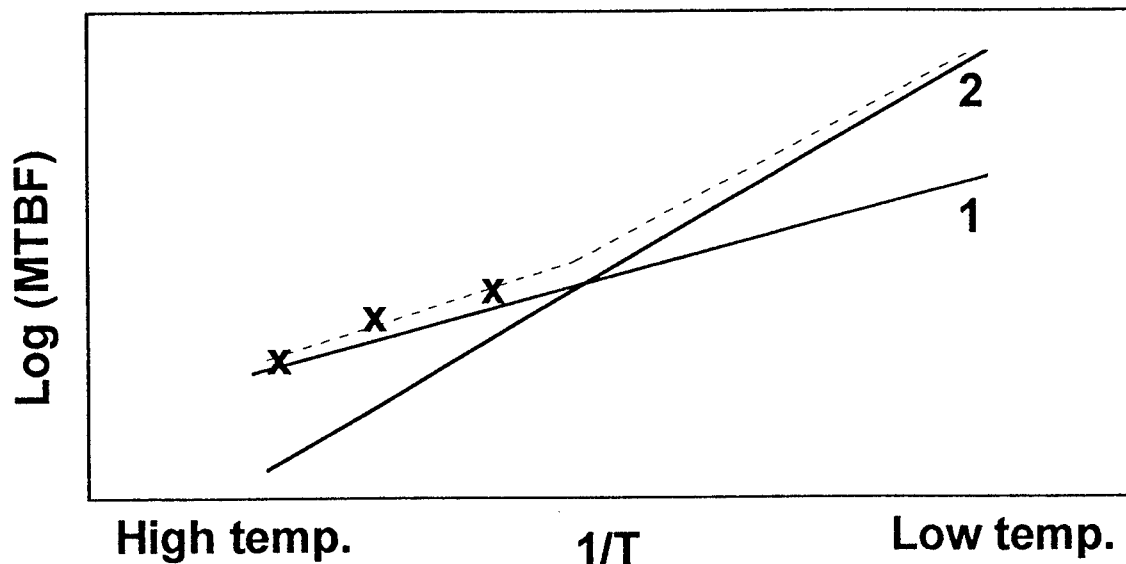
Figure 4: Illustration of two step failure mechanism. Solid lines represent Arrhenius plots of actual MTBF for each failure mechanism. Dashed line represents overall MTBF, which is sum of MTBF's from each step. Crosses represent measured data from which extrapolations are made.

The optical failures were assumed to follow an Arrhenius model for thermally activated processes. It should be noted that this simple model maybe an oversimplification of the failure mechanism. The BCM optical failure may occur in two steps, the first being package seal failure; the second being pigtail failure. In this case, the overall MTBF is

simply the sum of the MTBF's corresponding to seal failure and pigtail failure. The epoxies used for package sealing and pigtailing are different and are likely to have different MTBF and activation energies. If one step occurs much faster than the other than the MTBF will be approximately determined by the activation energy of the slower process. It is possible that in the temperature range where testing was performed, one process (say package seal failure) is the slower step, while at room temperature the other step (say pigtail failure) is the slower step. As can be seen in Figure 4, extrapolating to room temperature can lead to an erroneous result; however, the error creates an MTBF that is more conservative (shorter) than actual. In this analysis, it was not possible to separate seal failure MTBF from pigtail failure MTBF; therefore, one activation energy was used in the model.

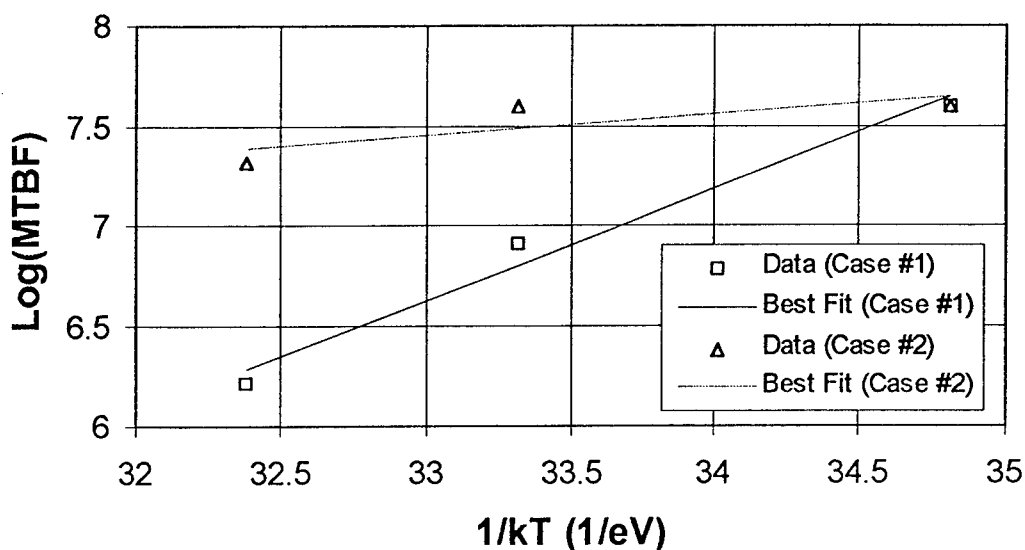
Figure 5: Arrhenius plot of MTBF data and least squares straight line fit. Case #1 and #2 use minimum and maximum possible values MTBF at high temperature, respectively.

The MTBF can be estimated at lower temperatures, by making an Arrhenius plot of the data, performing a least squares straight line fit, and extrapolating the least squares fit to lower temperatures. Uncertainty in measured MTBF at the higher temperatures can have a dramatic impact on the estimated MTBF; therefore, the extrapolation is performed for two extreme cases. Case #1 uses the minimum values for MTBF for Lots 3 and 4, whereas Case #2 uses the maximum values for those lots. It should be noted that the uncertainty in the MTBF at 75°C / 90% RH actually has a minor effect on the least squares fit, influencing the value at 25°C by less than 1%. The estimated MTBF at lower temperatures is mainly influenced by the values assumed for Lots 2 and 4. Figure 5 contains the Arrhenius plots of the MTBF data including the least squares fits. The measured and straight line fit MTBF are given in Tables 12 and 13 for the two cases and the activation energies are listed in Table 14. The MTBF from 25°C to 85°C is plotted in Figure 6. Note that the uncertainty in measured MTBF at higher temperatures creates large uncertainty in the estimated MTBF at lower temperatures. For example, MTBF at 25°C / 90% RH is estimated to be between 3200 hr and 20600 hr (2.3 yr).

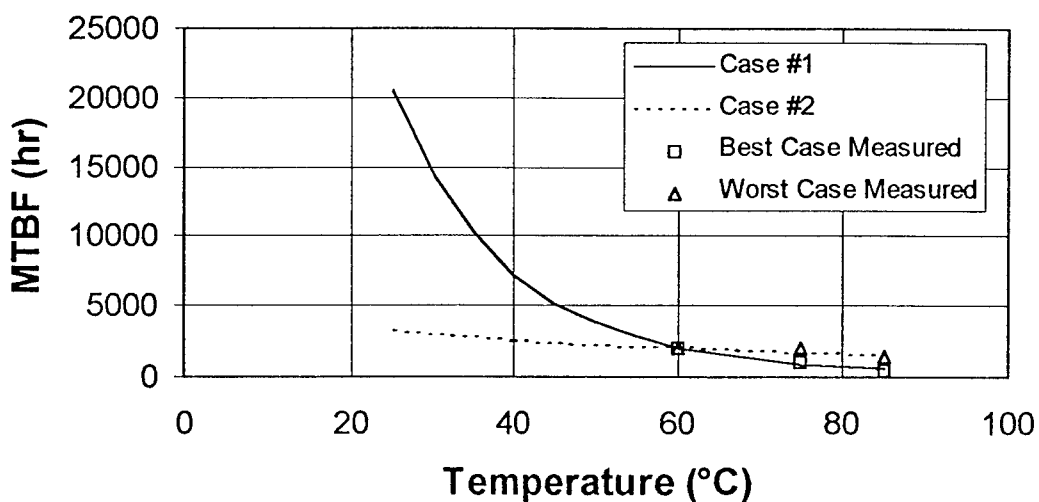
Figure 6: Plot of estimated MTBF at 90% RH for case #1 and #2, two extremes of possible values for MTBF, along with measured data. See text for explanation of large uncertainty in estimated MTBF at low temperatures.

The statistical impact of the small number of devices in each lot needs to be addressed. If the failure time for each device was accurately known, the distribution of failures with time would also be known, allowing an uncertainty in each measured MTBF to be determined. Given the small lot sizes and large time between measurements, this issue can only be addressed qualitatively. All of the devices in Lots 3 and 4 went from completely functional, with no detectable loss, to completely non-functional, that is, not passing light. The similarity of behavior suggests that the statistical effect of small lot size is much smaller than the uncertainty caused by the large sampling interval (1000 hr). It is possible that all the failures occurred abruptly over a period of a few hundred hours or less. Stated differently, increasing the size of the lots would not have changed the result much. All would have been functional at the start of the exposure period. All would have failed at the end. Lot 2 behaved differently in that the degradation occurred more gradually. One failure took place between 500 and 1000 hr and another failure occurred between 1000 and 2000 hr. The failures are likely to occur over a much larger period of time, perhaps 1000 hr. The impact on MTBF is significant. An uncertainty of 500 hr in the MTBF for Lot 2 translates into a factor of 2 uncertainty in the MTBF at 25°C / 90% RH.
